**CIVIL AIRCRAFT ACCIDENT No. CAV/ACC/6/22**

**FINAL REPORT ON THE ACCIDENT TO ATR 42-500 AIRCRAFT REGISTRATION  
5H-PWF WHICH OCCURRED ON 6 NOVEMBER 2022 IN LAKE VICTORIA NEAR BUKOBA AIRPORT**

## Civil Aircraft Accident No. CAV/ACC/6/22

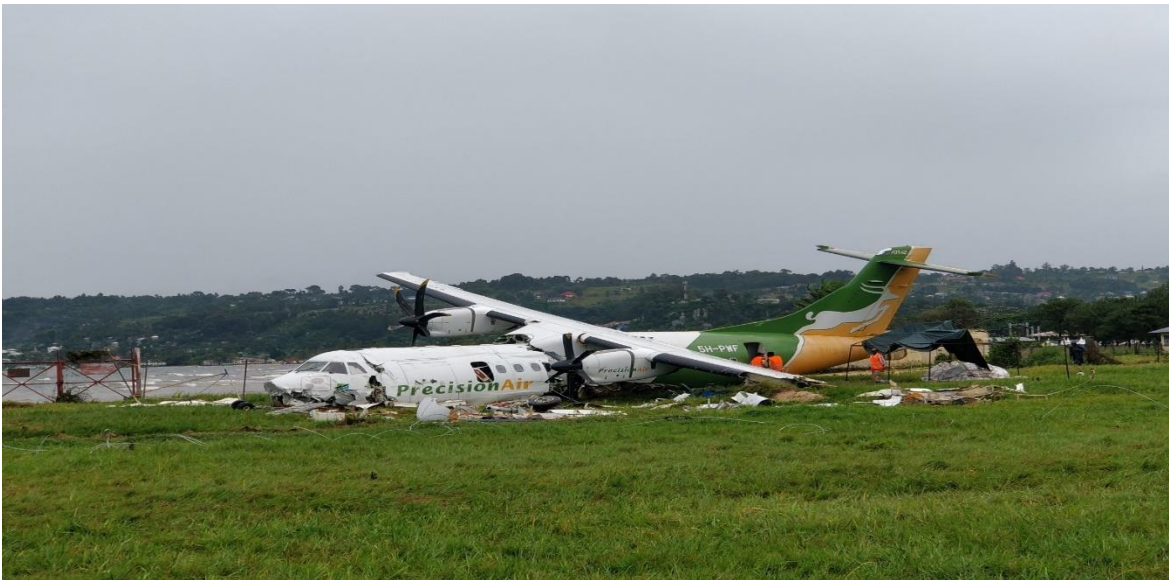
The aircraft was substantially damaged by impact with water and sustained more damage during recovery to the shore. It has since been declared written off.

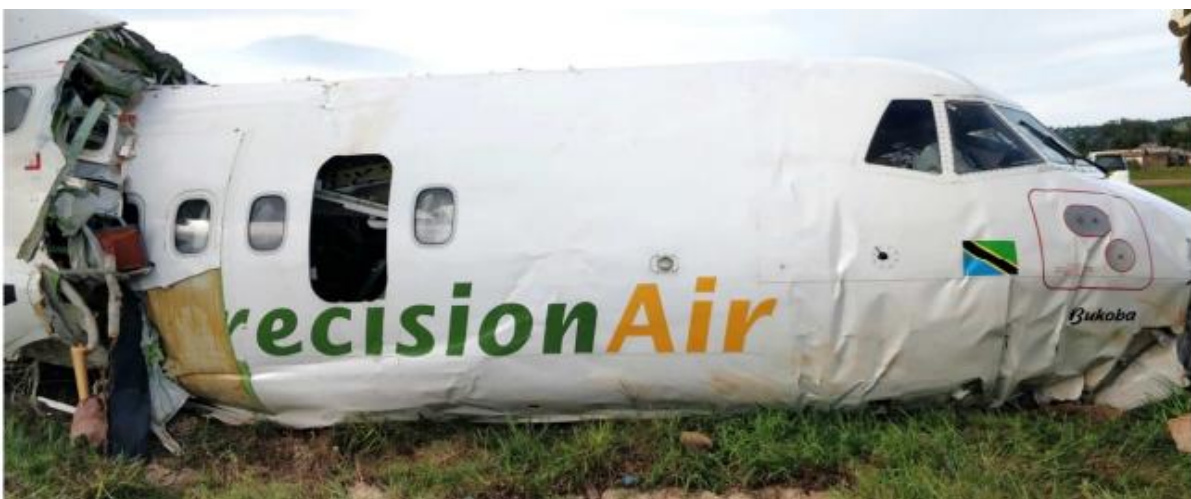
The nose and forward fuselage sections were significantly damaged whereas the aft section suffered minor damage. The radome was found completely separated from the fuselage.

The frame 1 bulkhead, the stiffeners and the Nose Landing Gear (NLG) bay were found severely deformed, buckled and fractured, consistent with heavy impact damage. The underneath section of the fuselage was significantly damaged, deformed and detached with broken belly fairing panels. Also wrinkled frames and aircraft skin were detached from the fuselage.

The floor panels and associated structures were heavily damaged. The skin was completely torn and the fuselage was almost separated between frame number 13 and 23.

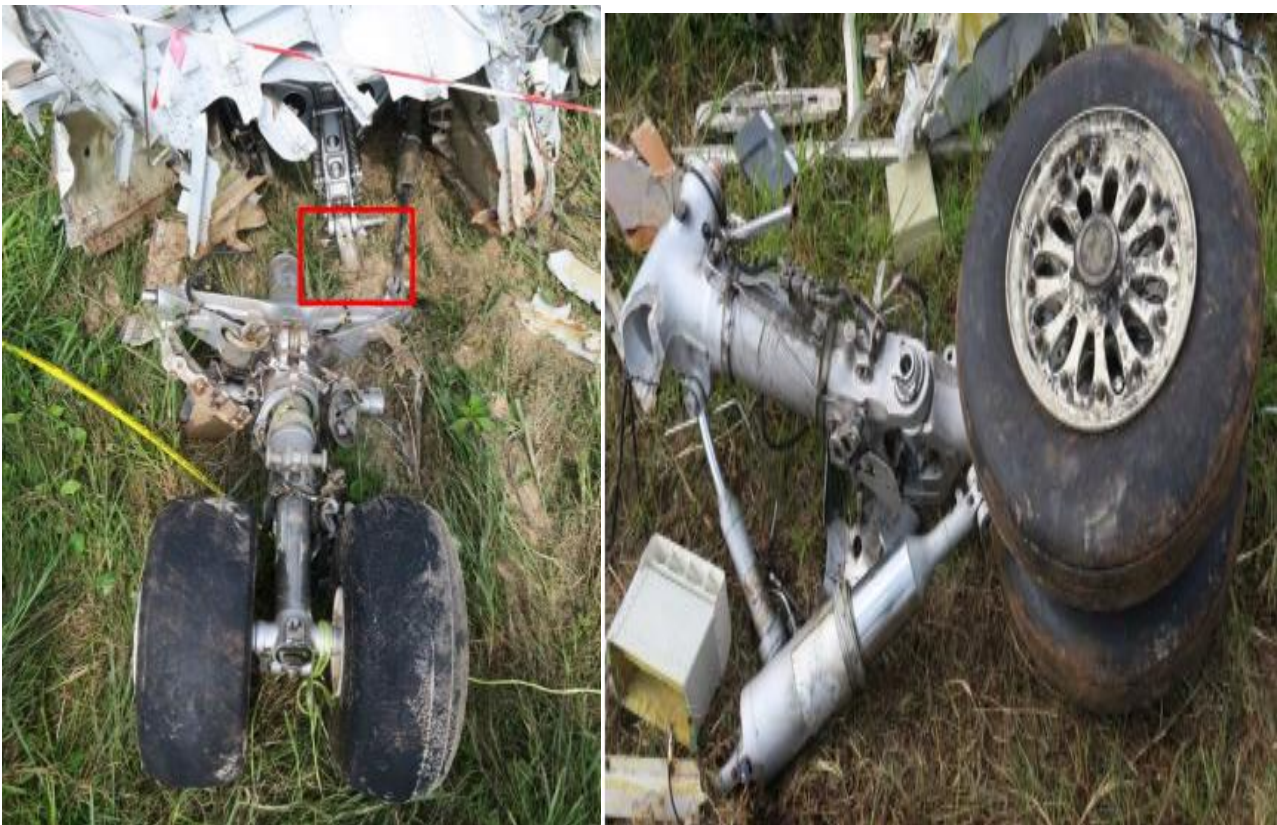
The right hand Main Landing Gear was found in extended position and still attached to the aircraft structure. The left Main Landing Gear was found separated from the aircraft, fractured at the middle of the upper leg and a deformed extension/retraction actuator.

The Nose Landing Gear assembly was separated from its main fittings but still attached to the actuator link. The connection with the drag brace was broken.

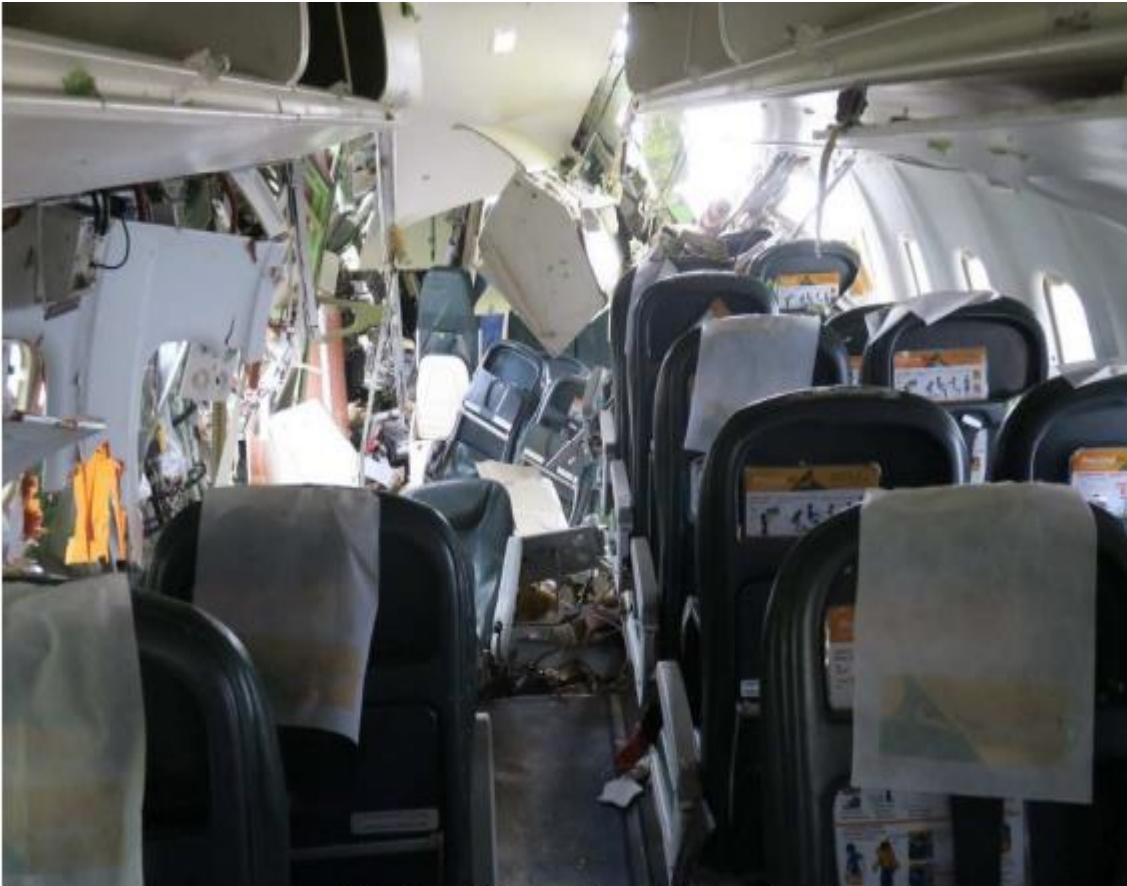
Cabin floor from seat row number 7 forward was significantly damaged, distorted and several passengers seats were partially or completely detached consistent with high energy impact with water.

Forward cabin crew seat was in place but the aft cabin crew seat had been completely detached from the floor and was found outside the wreckage.
